The Atlas of Hillforts of Britain and Ireland Hillfort survey (v2 October 2013)

- 2.1. Name of the site: Hunsbury Hill
- 2.2. Alternative name of the site: (previously known as Danes Camp in the 1800s)
- 2.3. National Grid Reference: SP7383 5836
- 2.4. Any known reference numbers: NA Vol 25/1994, pp 5-35; Tingle & Jackson, 2004 (see http://www.jwaller.co.uk/nas/Hunsbury_Hillfort.htm), Baker 1891; Dryden 1885; Elsdon 1976; Fell 1936; George 1917; Ingle 1993-4; Jackson 1993-4; RCHME 1985.
- 2.5. Current county/Unitary authority: Northamptonshire County Council
- 2.6. When did you visit the site (month/year): 21 January 2015

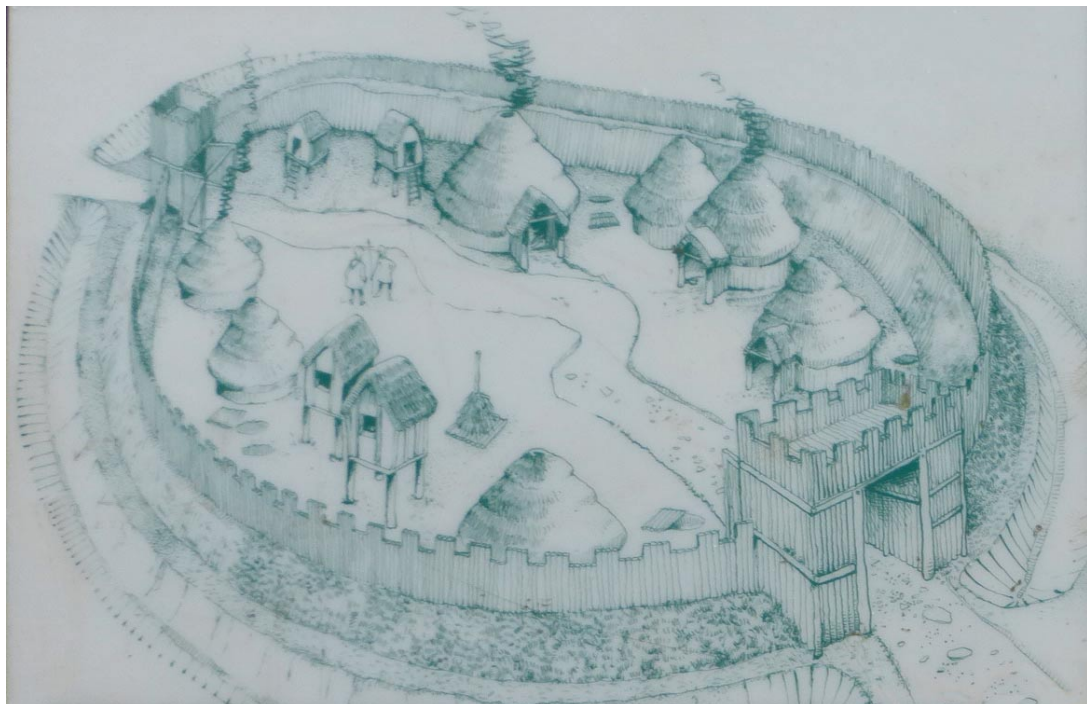
The artist's impression below, based on archaeological surveys, is shown on a signboard.

Comments: The two major breaks shown in the NW of the plan appear to be associated with an original main gatewayed entrance. The gap to NE is probably a relatively recent break in the circuit. The gap to the SE has been interpreted by archaeologists as an original secondary entrance – see artist’s impression sketch above.

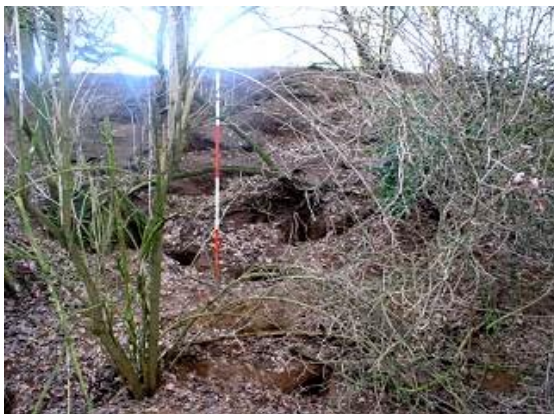
A section of the rampart damaged by trees and rabbits

- Control the rabbits by fencing around the damaged areas as well as the main access points to the top of the rampart.
- Encourage access to non-damaged sensitive areas by creating new pathways, and fencing off the main access points to damaged areas.
- Change the vegetation cover by replacing the existing shrubs with grass.
- Build a bank, 10 m wide, to support the internal rampart.
- Accept that damage will continue and excavate the remaining areas of archaeological

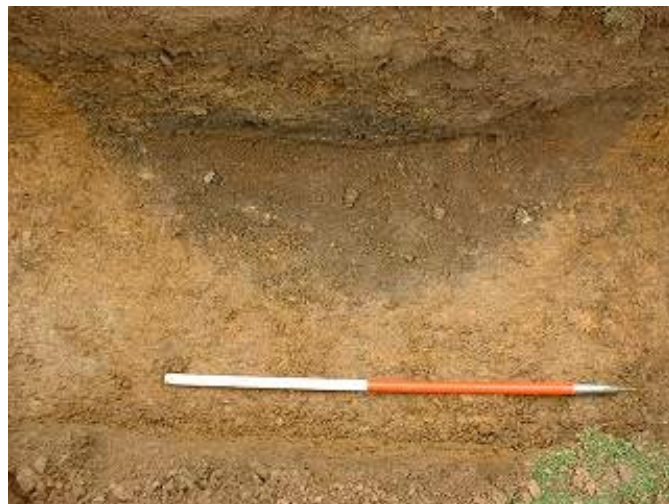
One of the pits in Trench 1 - it was from similar pits that a large assemblage of Iron Age metalwork was recovered during 19th Century quarrying.

They were each 80cm wide and varied in length from 8 metres to 15 metres. Trench 1 revealed a group of 3 large pits while in Trenches 2 & 3 other less substantial features were encountered. Comparing the results of the trial trenching with the location of the quarry edge that was assumed from nineteenth century records, it appears that the surviving area is larger than had been previously imagined. The trenching has revealed that there is between 25 to 35cm of plough soil above the natural bedrock of ironstone grits or silty clay, and that no Iron Age levels survive in the area of the trenches. There is no evidence that overburden was dumped on the unquarried area during the quarrying .

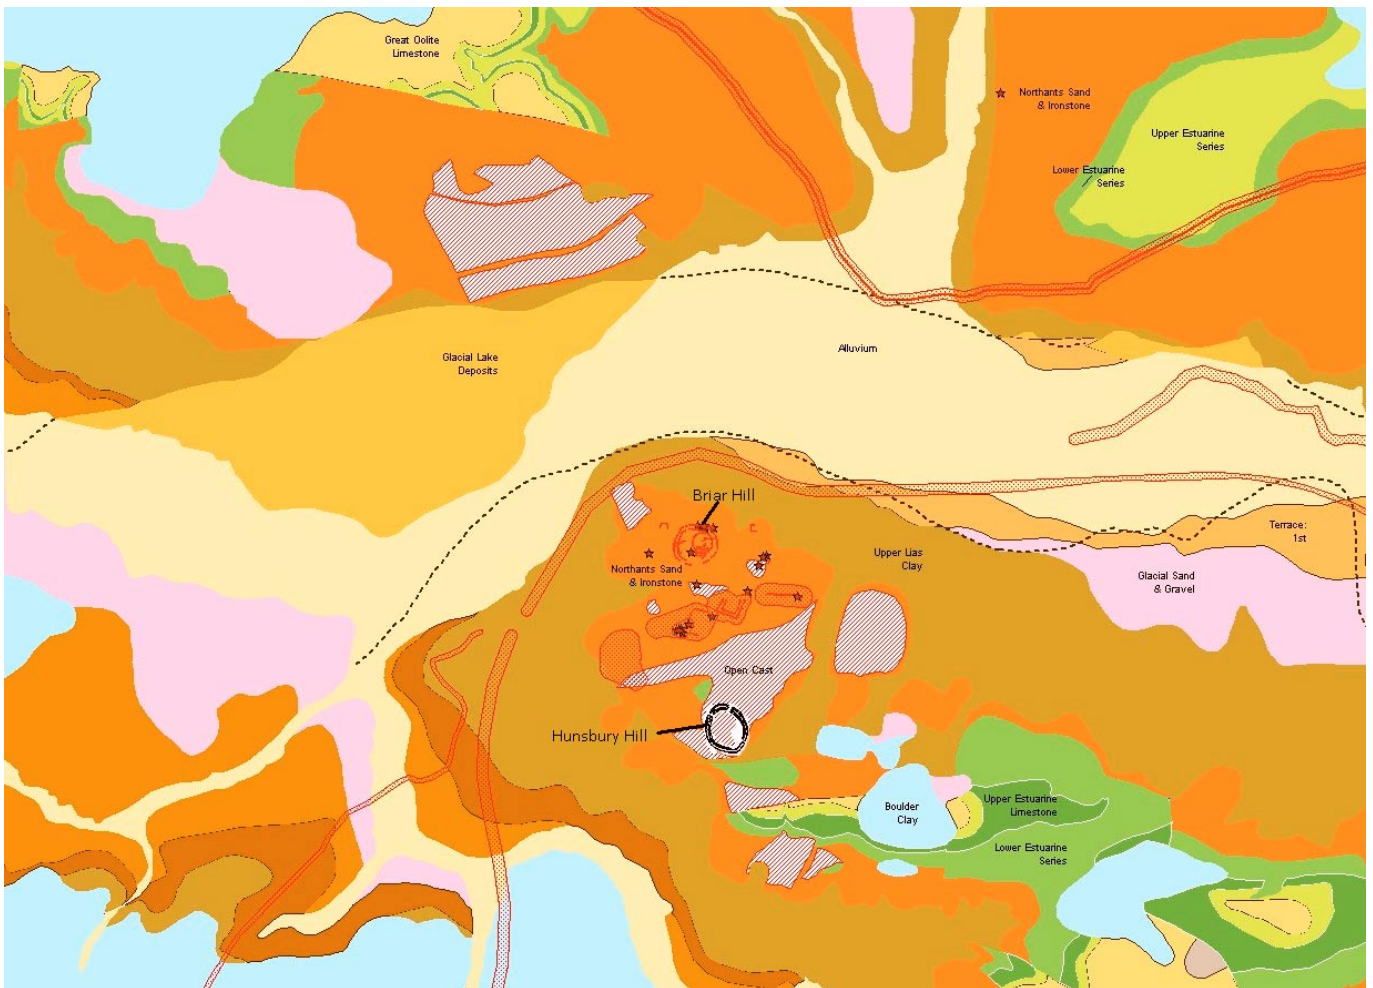
Geological map showing Hunsbury Hill and Briar Hill

The Hunsbury Hill and Briar Hill sites are both located on an outcrop of Northants Sand & Ironstone that is particularly rich in iron.

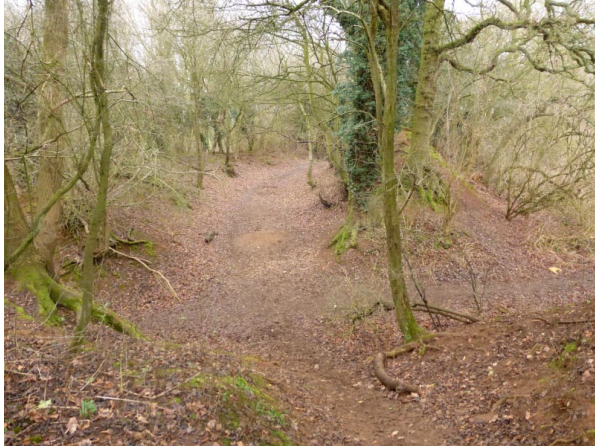
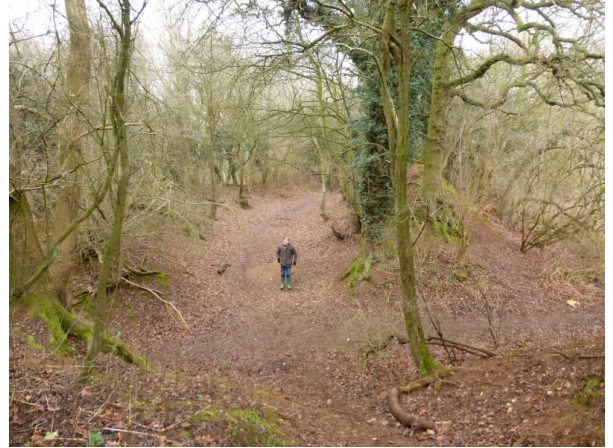
1-2: the depth of the ditch, viewed from above, is only apparent when the human figure is included.

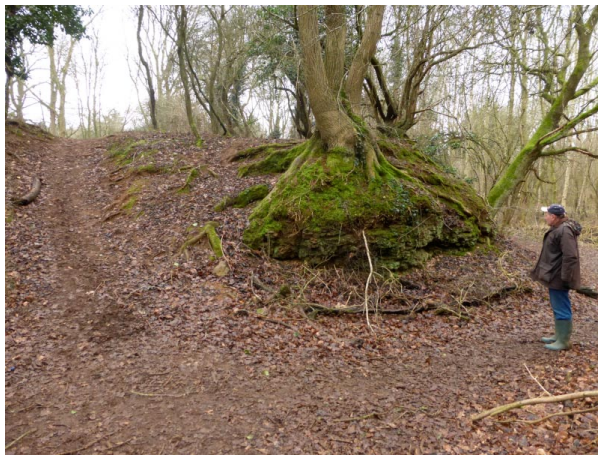
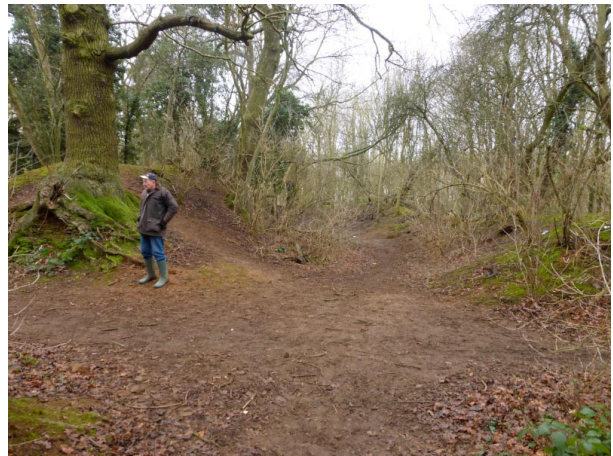
3-4: the depth of the ditch is more evident in these photographs.

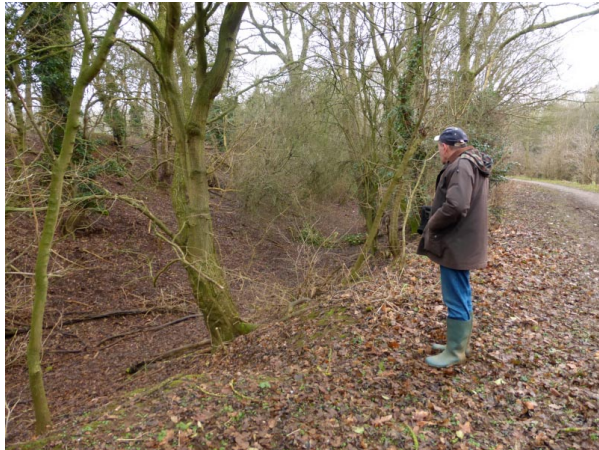
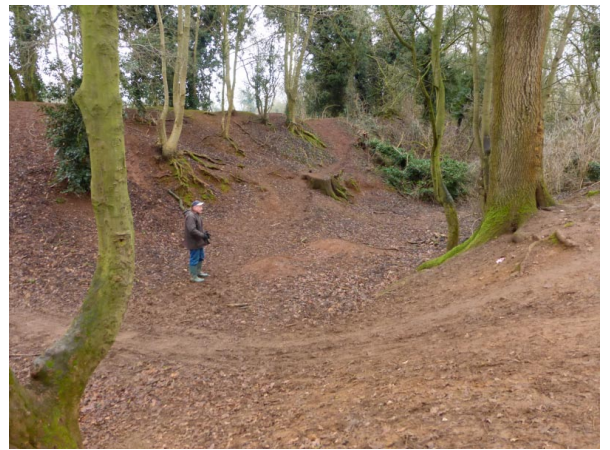
6-7: the ditch on the north-east side.

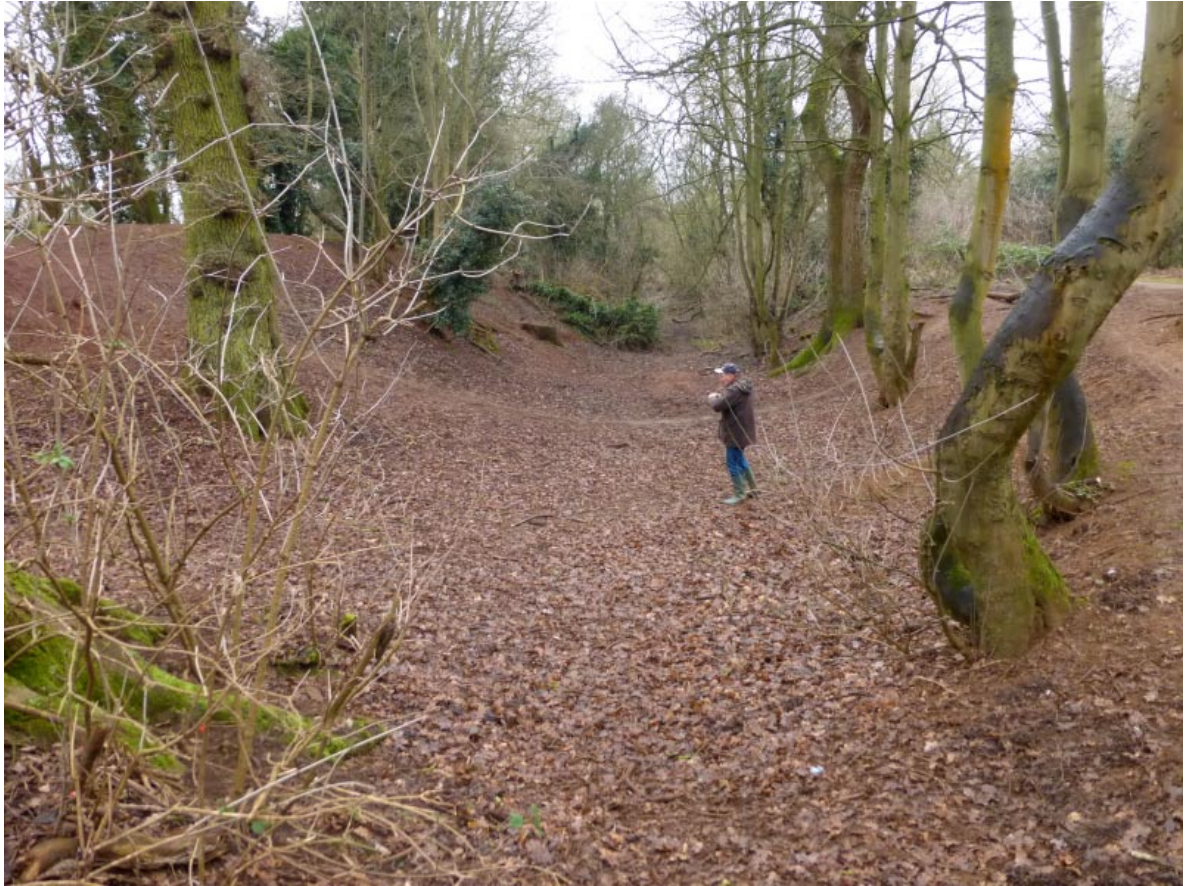
8: the ditch on the north-east side. Tree-roots are actually the only things that are keeping some parts of the ditch walls in place!

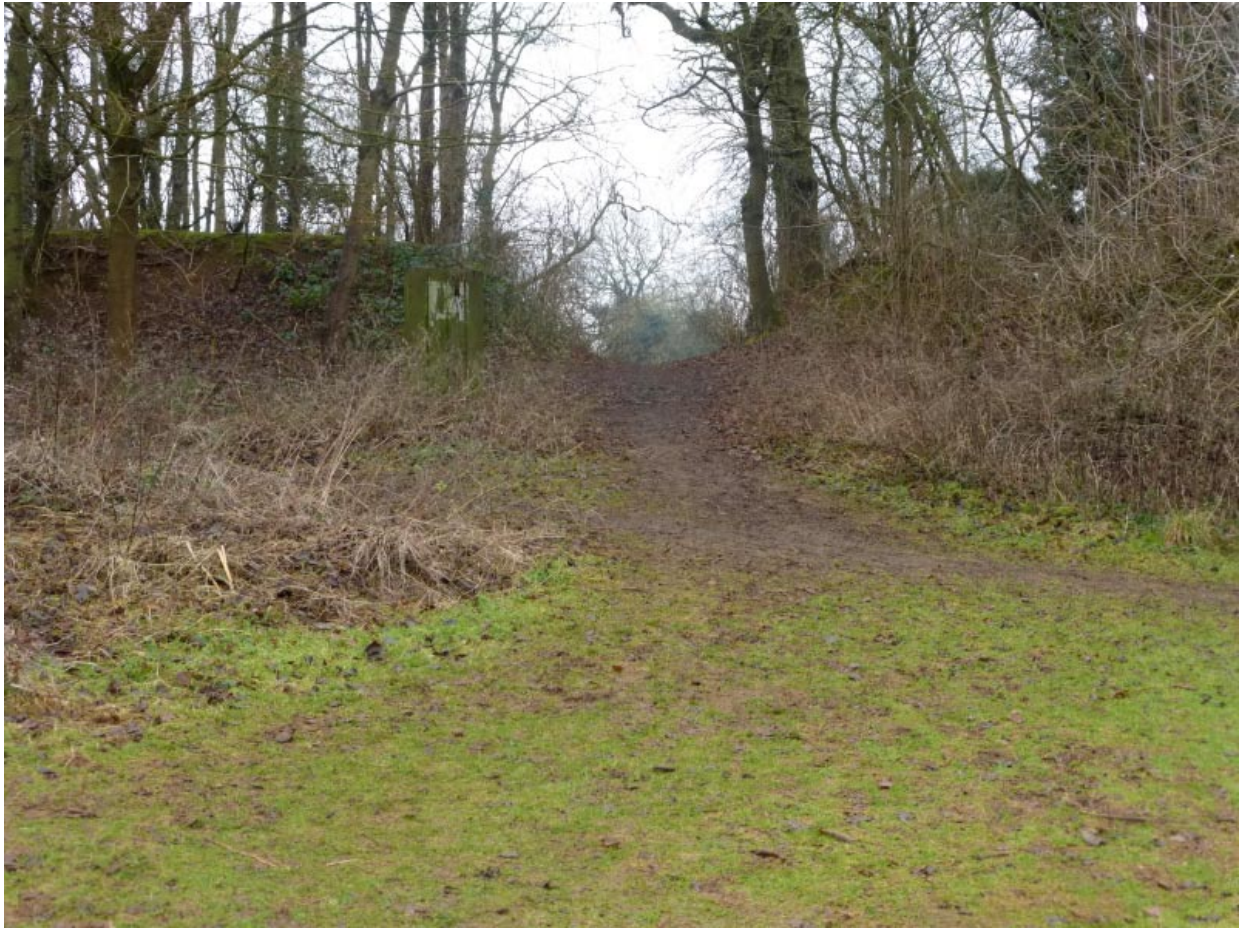
12: This illustrates the extent to which C19 open-cast quarrying has reduced the level of the ground surface both inside and outside the ditch and its banks.
